N.A.C.A. STALL-WARNING INDICATOR

By F. L. Thompson
Langley Memorial Aeronautical Laboratory

Washington
October 1938

TECHNICAL NOTE NO. 670

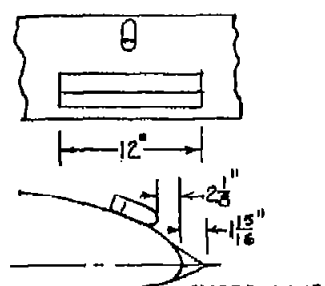
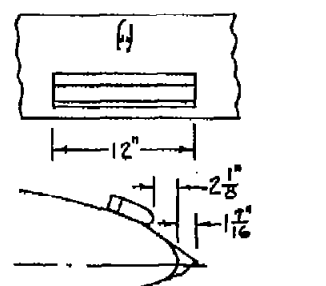
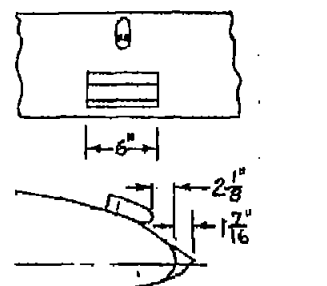
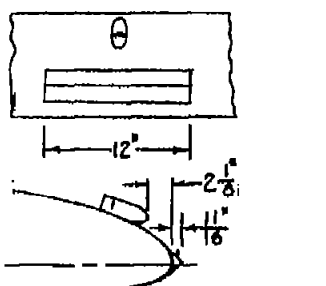
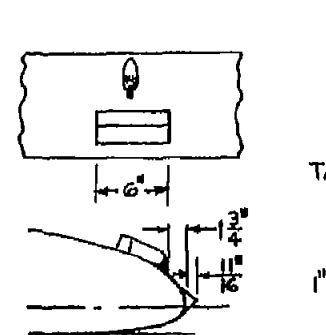
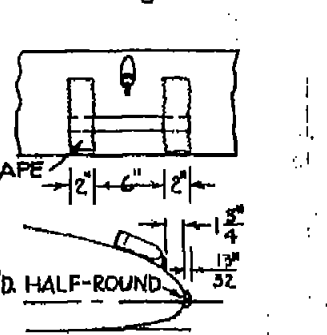
TABLE I.- TESTS OF STALL WARNING DEVICE - ARRANGEMENTS TESTED AND RESULTS.

<p>E</p>
<p>Satisfactory with flaps up. Not tried with flaps down.</p>	<p>Satisfactory.</p>	<p>Unsatisfactory. Insufficient and erratic warning.</p>	<p>Unsatisfactory. Insufficient warning with flaps up.</p>	<p>Satisfactory.</p>

<p>H</p>		
<p>Satisfactory.</p>	<p>Unsatisfactory. Insufficient warning, particularly with flaps up.</p>	<p>Satisfactory.</p>

It appears from a study of the results given in table I that the functioning of the stall-warning device is adjustable through a considerable range by means of alterations of the shape and size of the sharp edge and of the nose of the head. It appears to be very important that the dynamic opening of the head be close to the wing surface in order to avoid the necessity for a large, sharp edge. With the dynamic opening above the wing surface about one-half inch as it was with the original nose piece, satisfactory results were obtained only with the large, sharp edges of arrangements A and B. With the dynamic opening brought down close to the surface, satisfactory results were obtained with the sharp edge reduced to a length of 6 inches in a spanwise direction and an extension of $11/16$ inch in a chordwise direction (arrangements F and H). A further reduction in size might have been possible but appeared to be unnecessary in view of the apparent insignificance of the alteration of the wing contour.

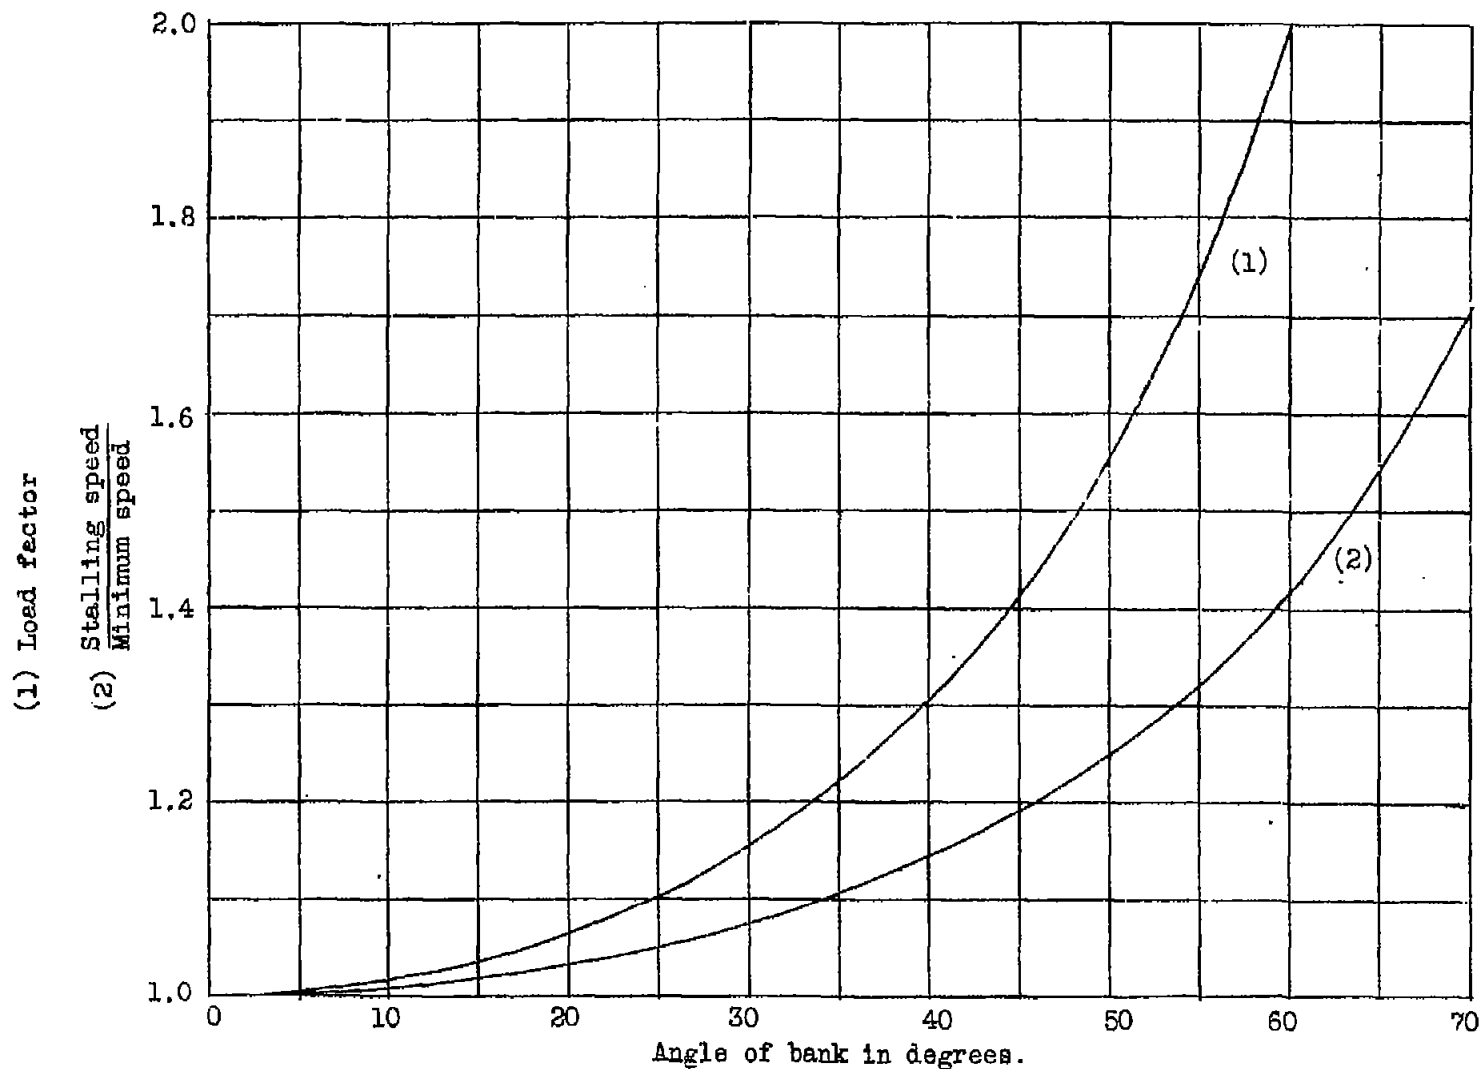
Figure 1.- Variation of load factor and ratio of stalling speed to minimum speed with angle of bank in horizontal turns.

The load factor and the ratio of V_{stall} to V_{min} in turns are plotted in figure 1 to show how these quantities vary with angle of bank. The curve of stalling speed is an ideal one that does not take into account the influence of errors in the air-speed meter reading. In general, such errors will further complicate the situation because calibrations made in steady flight will not apply in accelerated flight unless the correction for position error of the air-speed head is negligible. If an instrument is to be used to give a warning of the stall, therefore, it appears desirable that its functioning should be dependent on angle of attack rather than air speed. Furthermore, it seems desirable in order to avoid the necessity for watching the instrument continuously that it be arranged to give a warning signal when a safe limit has been reached.

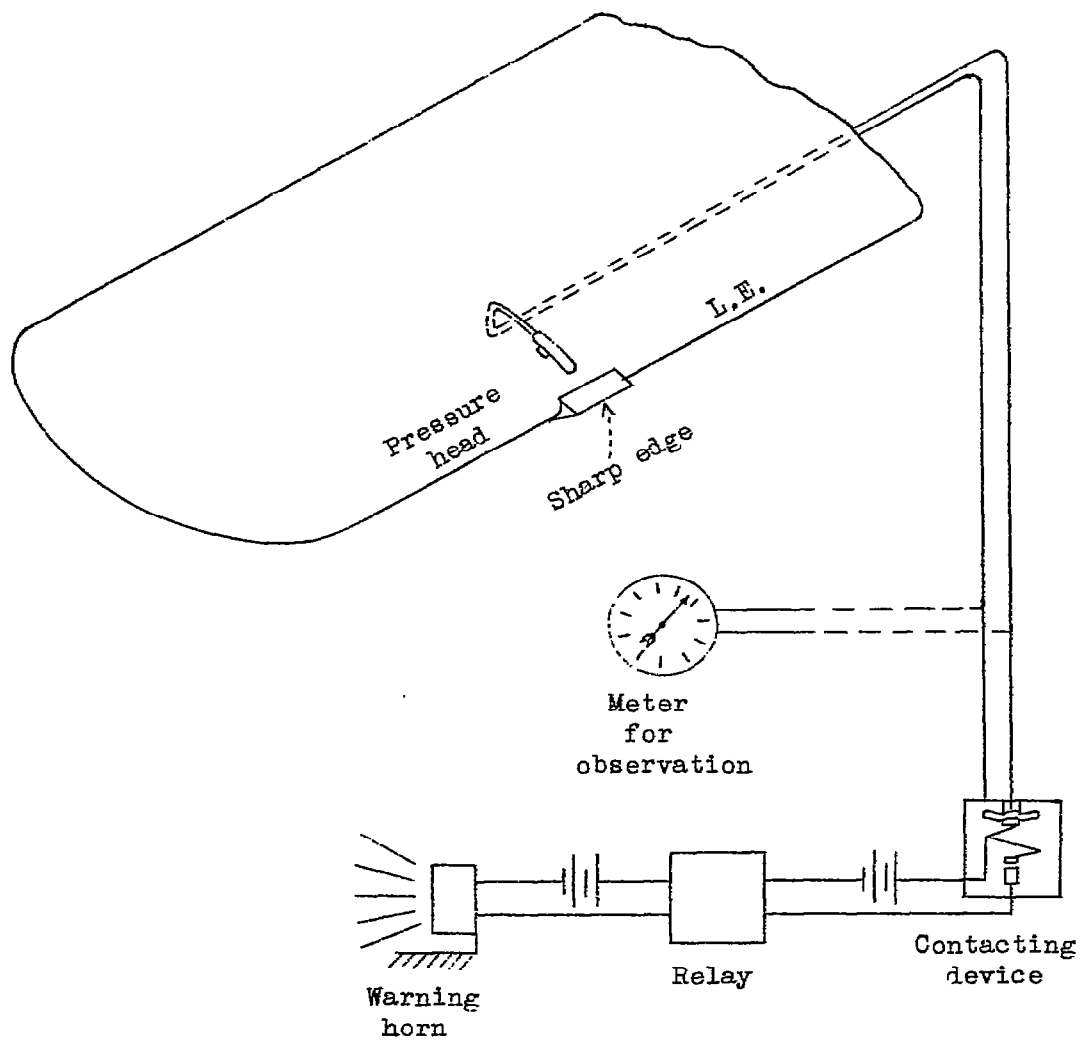
Figure 2.- Diagram of stall warning device.

A stall-warning device developed by the National Advisory Committee for Aeronautics is shown diagrammatically in figure 2. It makes use of a modified type of pitot-static head set close to the wing surface in a region wherein stalling occurs (or is made to occur) at an angle of attack considerably below that at which the main portion of the wing stalls. This head is connected to a pressure cell fitted with electrical contacts and for observations during tests it may also be connected to a conventional air-speed meter. When the air flow in the region in which the head is located breaks away from the wing surface, that is to say, when local stalling occurs, the pressure indicated by the head drops sharply to zero. When this occurs the electrical contacts close a circuit that operates a warning signal. The signal as used in flight tests of this device was a horn such as that used with retractable landing gears, but of course any suitable type of warning may be used.

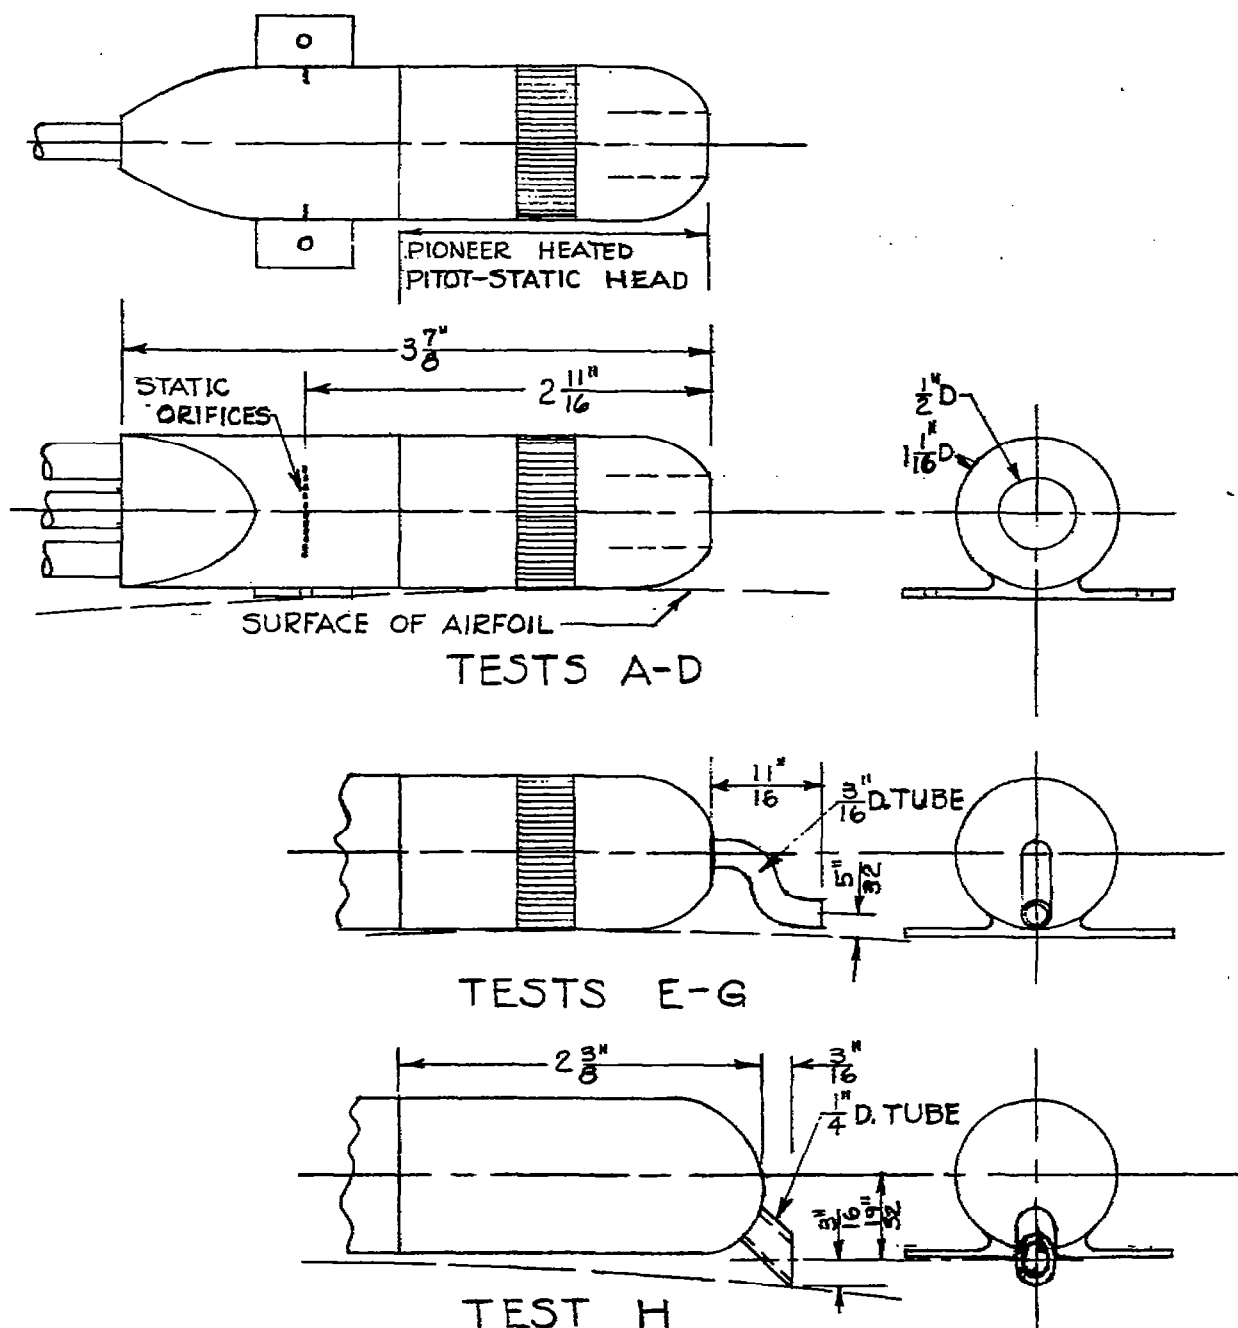
FIGURE 3.- PRESSURE HEADS USED WITH STALL WARNING DEVICE.

The head used in the experiments with different nose pieces is shown in figure 3. Table I shows the various arrangements of sharp edge and head that were tested and figure 4 shows photographs of combination H. For the tests the contacting device was set to operate when the local air speed as indicated by the stall-warning device dropped below 70 miles per hour. As will be shown later, this setting was appreciably below what would normally be the local velocity over the curved portion of the leading edge of the wing at the minimum speed of the airplane on which the tests were made. A considerable variation of this setting, however, would not have altered the results appreciably.

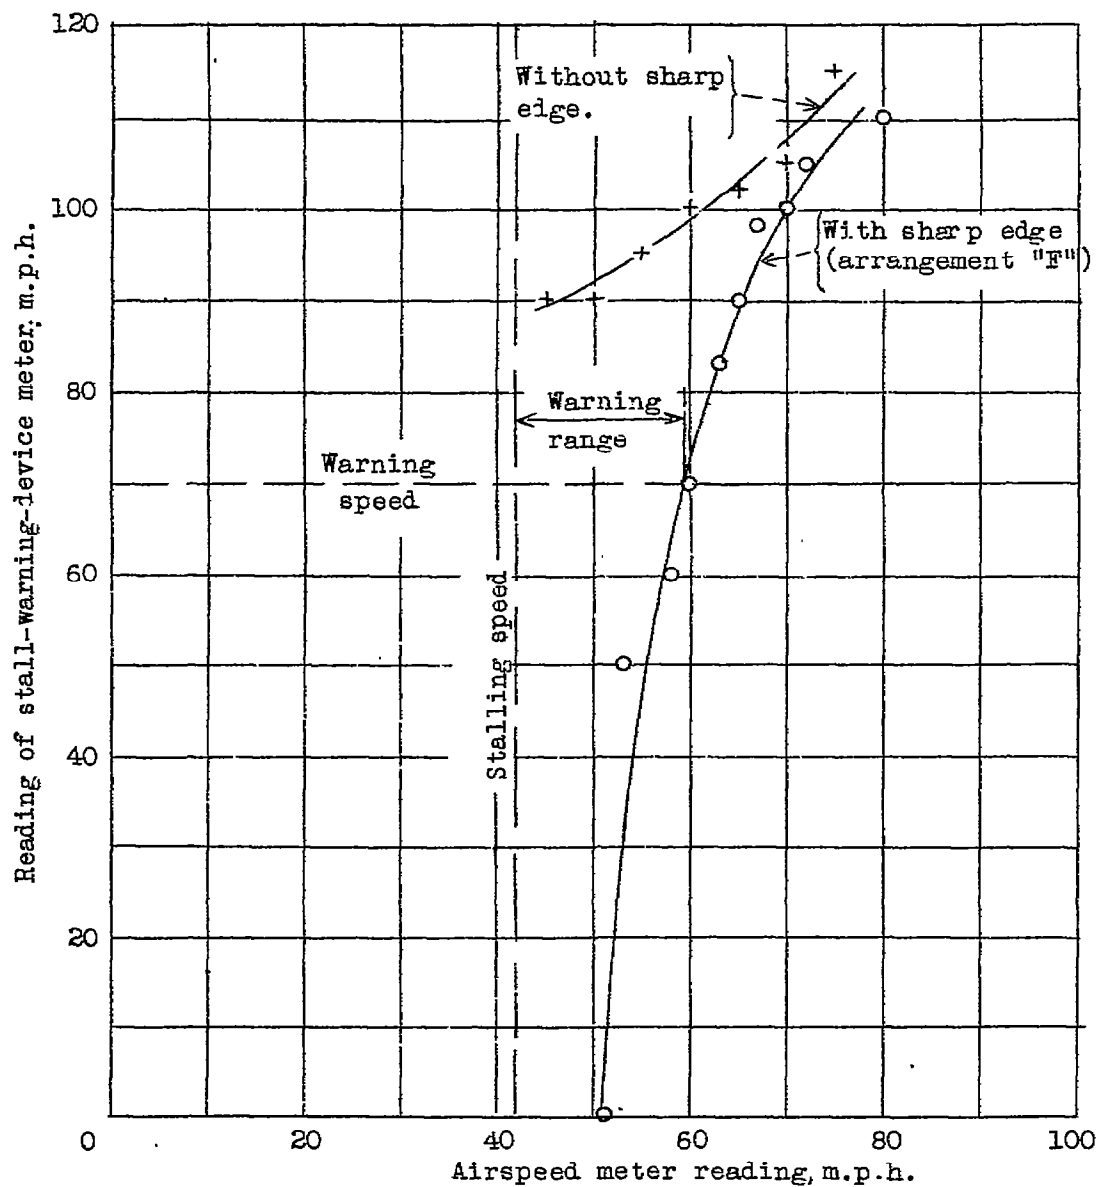
Figure 5.- Characteristics of stall-warning device for typical case.

Before a comparison is made of the results obtained with different arrangements, it seems advisable to describe the general characteristics of the behavior of the device by reference to figure 5. This figure shows the readings of the meter connected to the stall-warning head plotted against the readings of the air-speed meter of the airplane with arrangement F and also with the sharp edge removed. The results shown in this figure for arrangement F are typical of arrangements considered to be satisfactory. It will be noted that whereas the reading of the air-speed meter of the airplane at minimum speed is 42 miles per hour, the warning is obtained at about 59 miles per hour, the speed at which the local velocity falls below 70 miles per hour. Without the sharp edge the local velocity over the leading edge of the wing does not fall below 90 miles per hour. It may also be noted that, although the device was set to warn when the local velocity reached 70 miles per hour, a change of setting of several miles per hour in either direction would not have greatly altered the airplane speed at which the warning occurred. In other words, the adjustment of the contacting device was not critical. One other point of practical interest brought out by figure 5 is that in the normal flight range the local velocity is considerably greater than the air

speed of the airplane, so that the pressure unit used in the contacting device must be rugged enough to withstand pressures much larger than the dynamic pressure corresponding to the maximum speed of the airplane relative to undisturbed air.
